The Tectonics of the Double Skin:

Green Building or Just more Hi-Tech Hi-Jinx?

NORTH AMERICAN CASE STUDIES:

Terri Meyer Boake, Associate Professor

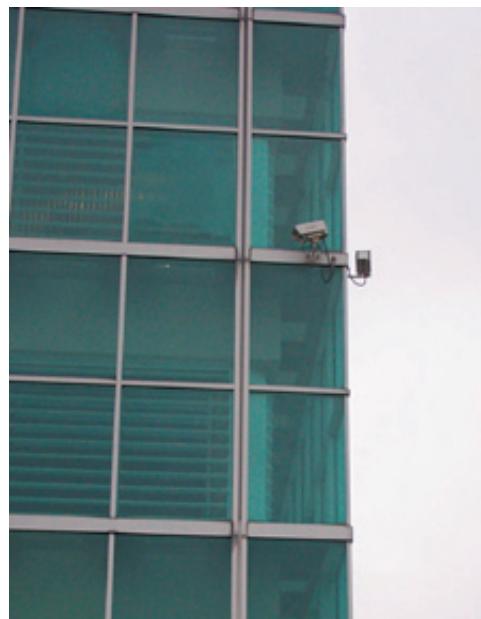
Detail of corner of building

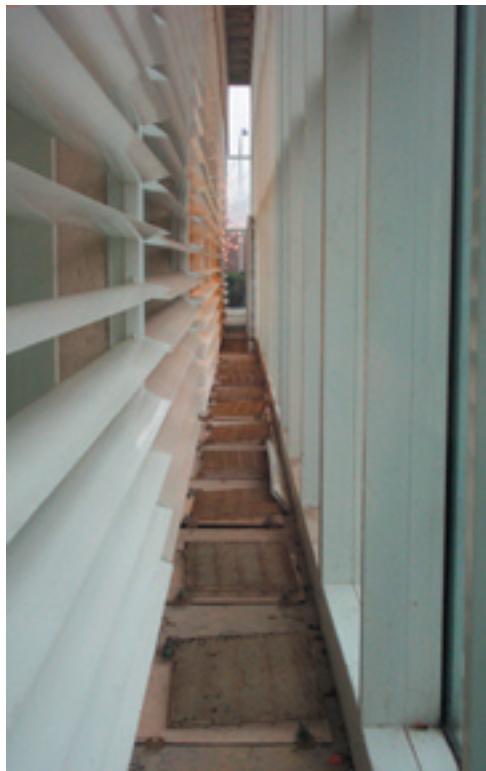
A view inside the cavity showing its clear width to allow for maintenance; the plywood sheets that close off the grille at the base preventing air intake.

Approaching the building, it looks to be in pristine condition. Closer examination would reveal otherwise. Many of the original design intentions and systems of the buffer façade system are no longer functioning – either in whole or in part. A significant percentage of the glazing appeared to be clouded. We initially assumed these panels to be the result of a broken seal on a double glazed unit. This proved incorrect. The coating on the interior surface of the exterior glazed skin was disintegrating or delaminating. Proper maintenance and cleaning of the louvers has not taken place. The air space and associated louvers were “filthy”. This could be credited to lack of cleaning, or, site conditions as a result of the recent excavation. The grilles at the base of the cavity are presently closed off with large plywood planks. Although the cavity was originally outfitted with motorized dampers, the presence of the plywood would indicate that these are no longer functioning.

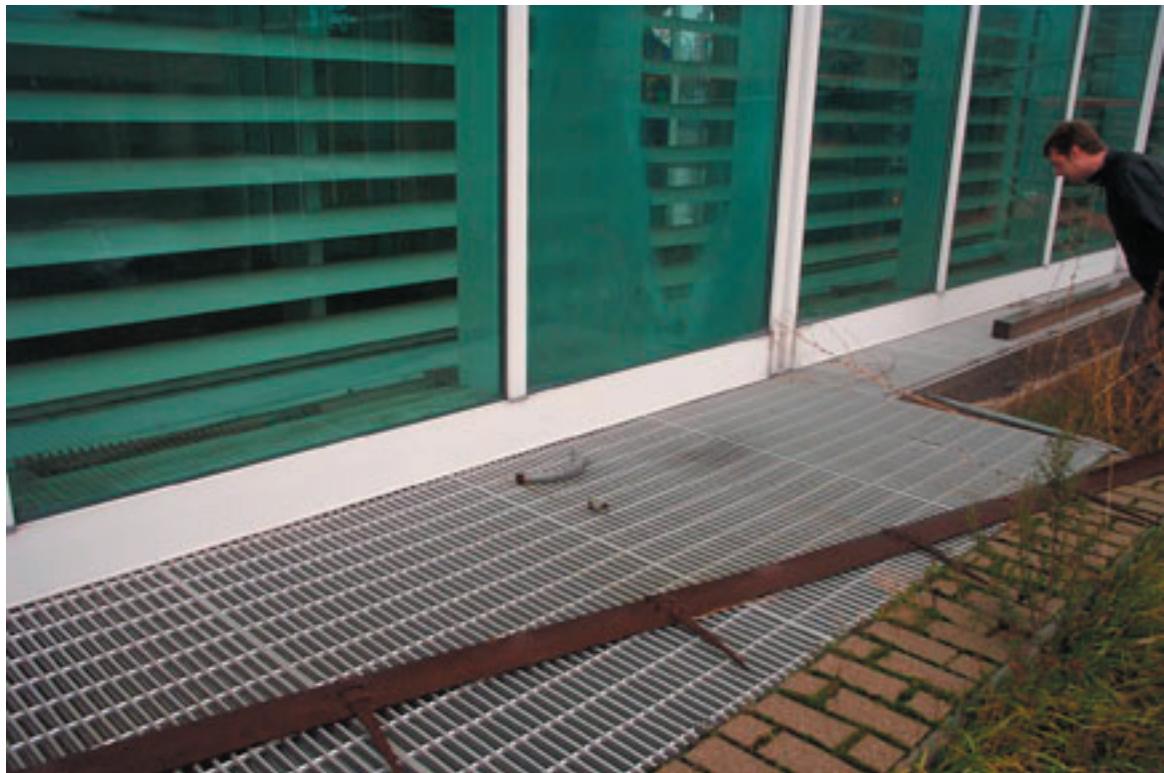
View of air intake grille at base of building. Note clouding on center glazed unit.

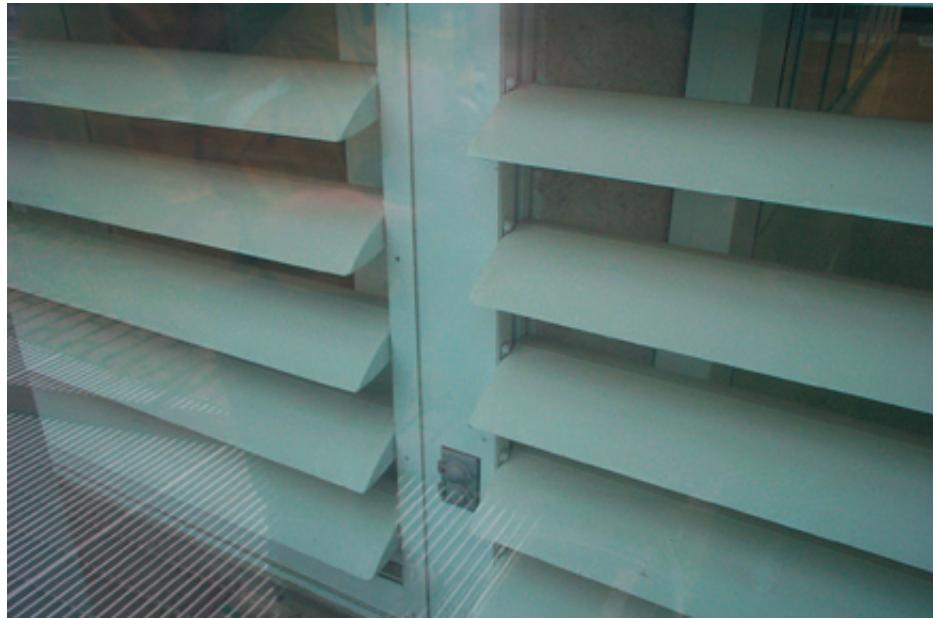
It can be seen that the louvers are fixed in a horizontal position, painted white and are very dirty.

According to security and maintenance, the brightly finished louvers were painted white early on in the life of the building due to the glare issue. This would have had an appreciable change on the diffusion of sunlight into the building. The computer controls for the louvers ceased to function approximately 4 years ago. They have not been repaired. They are now fixed in a horizontal position – inferring that they will provide only partial shading (particularly on the east and west elevations). It was apparent that tenants had decided to supplement the building shading with their own “personally controllable” louvers in the form of vertical blinds.

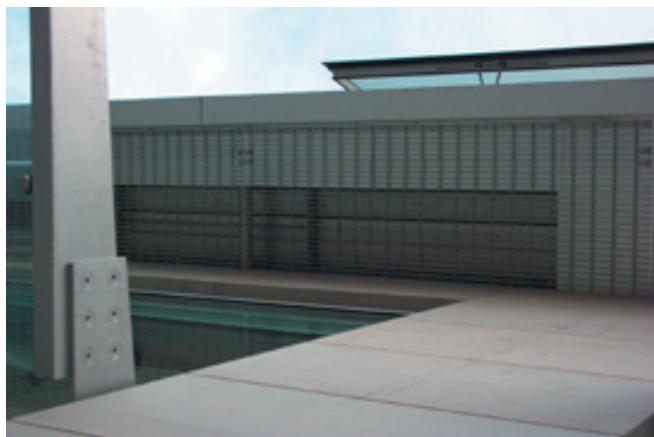
*Winter Wall Section:
Dampers Closed*

"The double skin acts as a ventilation chimney in warm weather and as an insulation jacket in cool periods. In winter months louvers at the top of the double skin remain closed, trapping a layer of air, allowing the building mass to retain available solar energy, which is then reradiated into the building. The exposed concrete structure acts as a heat sink, helping to reduce temperature fluctuations. In warm weather, with the louvers open, heat building within the double façade causes convection air movement. Assisted by fans, warm air is drawn up and out of the top of the air space, creating negative pressure within the interior, which in turn draws warm air away from the occupied areas." John McMinn, 2001

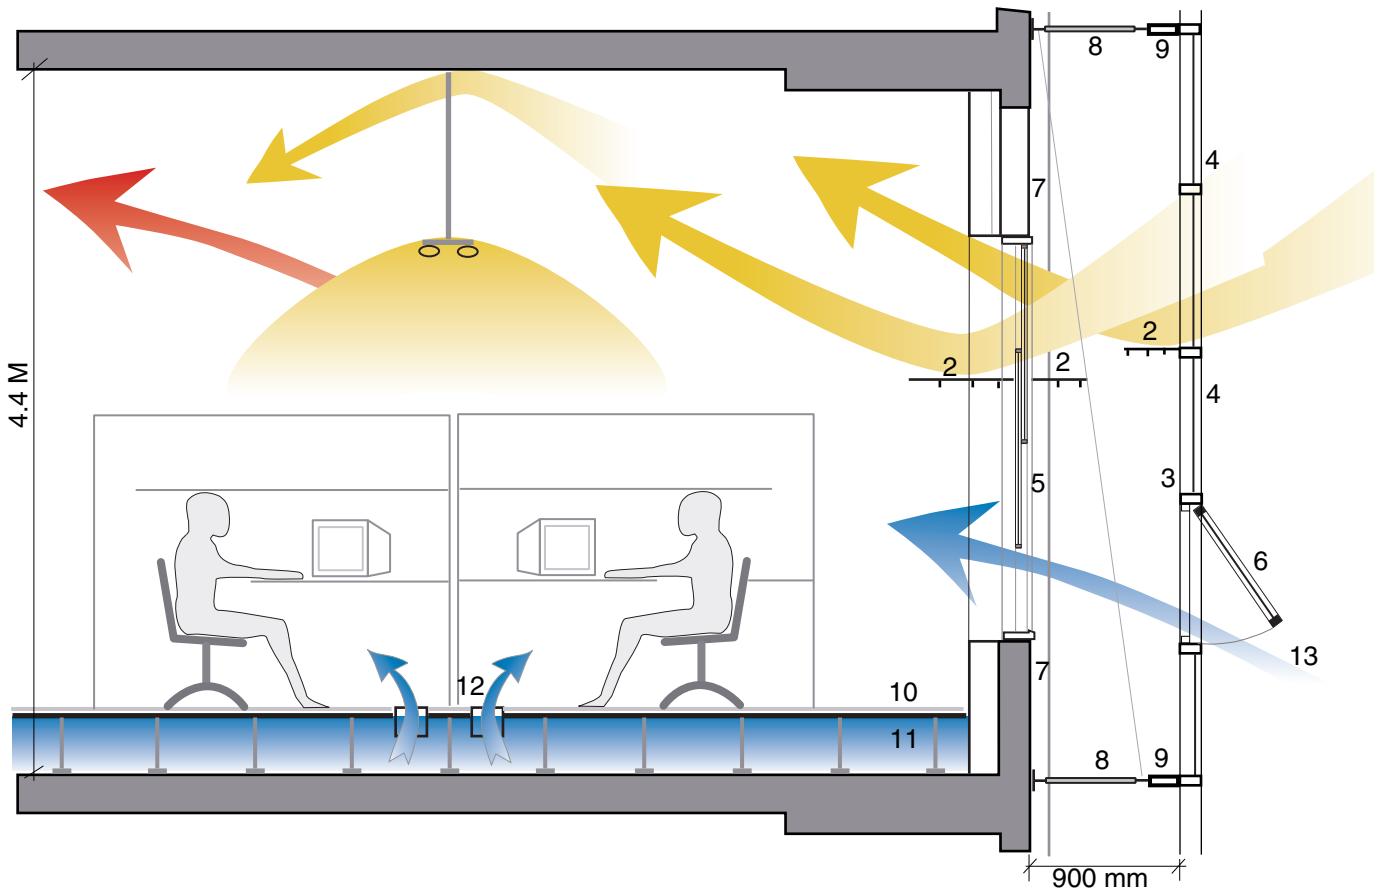
Detail of Wall to Room Function:

- 1 Interstitial space - seasonal climate buffer zone
- 2 Daylight reflector and sunshade
- 3 Aluminum framed glazing curtain wall
- 4 Solar shade glass panel - ceramic frit glass panel reduces solar heat gain
- 5 Operable windows - existing restored
- 6 Operable windows - new mechanized
- 7 Existing exterior wall - exposed concrete
- 8 Curtain wall hangers
- 9 Steel reinforcing for curtain wall frame
- 10 Raised office floor
- 11 Air plenum in raised floor
- 12 Air diffusers
- 13 Natural ventilation possible in moderate temperatures

The existing windows were restored to operating condition. This provided both a cost and an environmental savings. To supply fresh air, mechanized operable windows were fitted on the new glazed wall. The existing brick veneer was removed. The exposed concrete acts as a heat sink. The curtain wall is hung off of the existing building with steel brackets and supports. The new glazing wall extends beyond the property line of the site, but as it only starts below the second floor level, does not impinge on the sidewalk space.

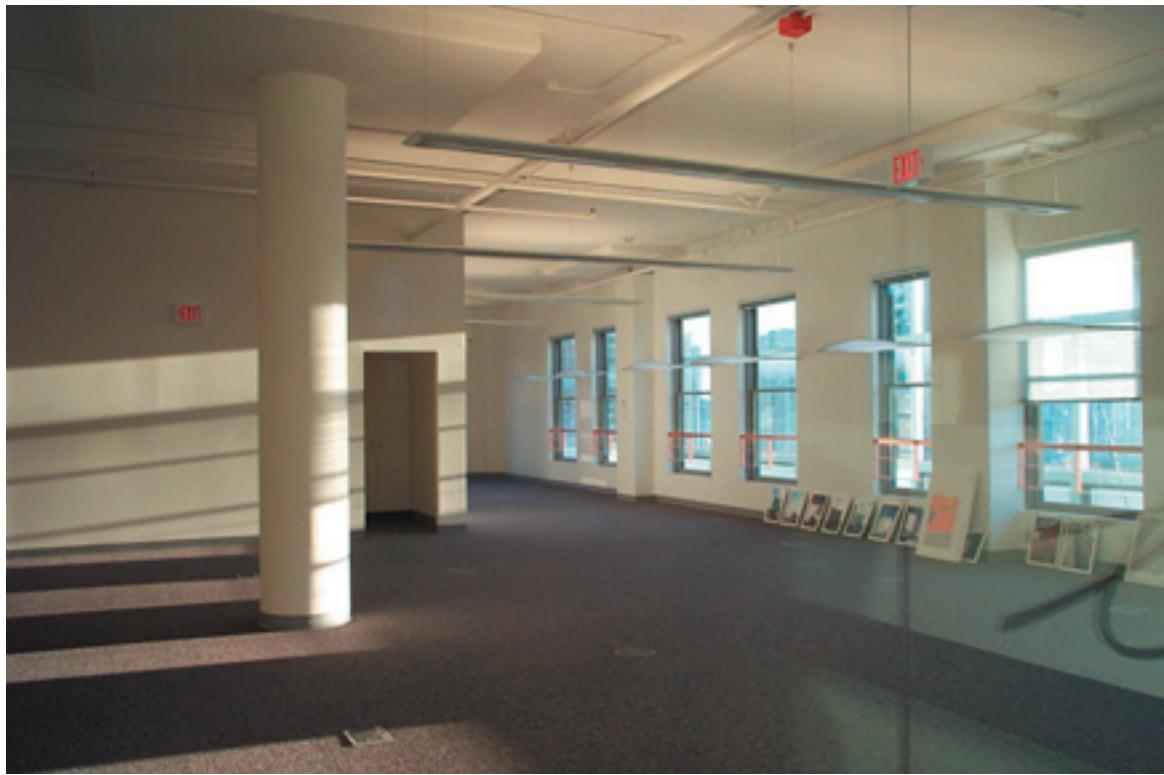
View of interior, façade faces south-west, 4 p.m., November

This image was taken prior to occupation. The white painted interior was very brightly lit. The low sun angle provided penetration to the back corners of the office space. Much shading is provided by the existing concrete wall. In fact, were it not for the ratio of wall to window area, the glare in the space would make the working condition impossible.

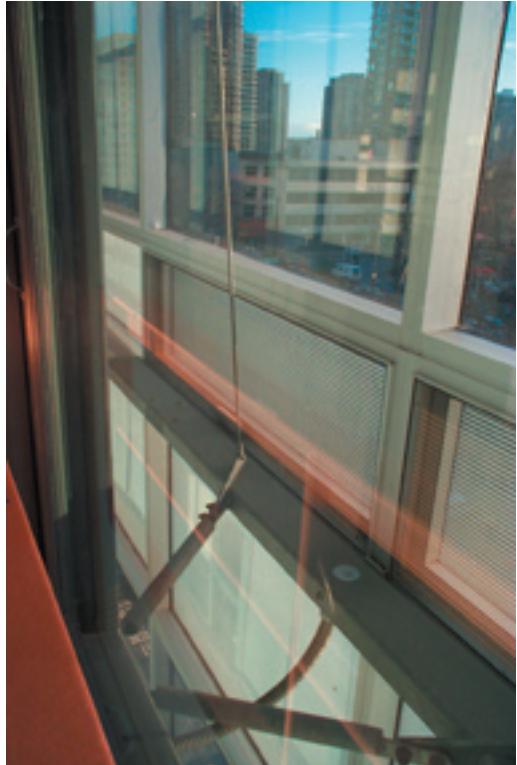
Views looking into the cavity. Note the differentiated glazing materials: clear and fritted, as well as the operable window.

Whereas the glass on Occidental Chemical is uniform over the entire building envelope, the Telus Building has used differentiated glazing: clear vision glass in a band on the exterior skin that aligns with the interior windows, and fritted glass in the “spandrel” sections to cut out unnecessary heat transfer.

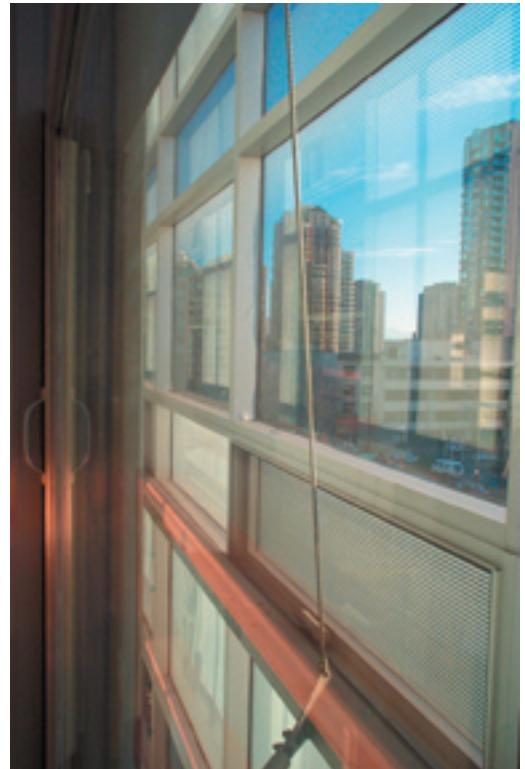
The envelope helps to modulate internal temperatures. Motorized windows on the new curtain wall, as well as operable existing units, enable the occupant to obtain natural ventilation when possible. The window glass on the curtain wall is fritted at different densities for temperature modulation. Photovoltaic panels are fitted in the new curtain wall and are linked to ventilation fans and dampers on the roof that ventilate the interstitial space. Each workstation is equipped with individually controlled diffusers to allow the flow of fresh air through a forced air plenum under the raised floor. The daylight reflectors allow light to penetrate deep into the building.

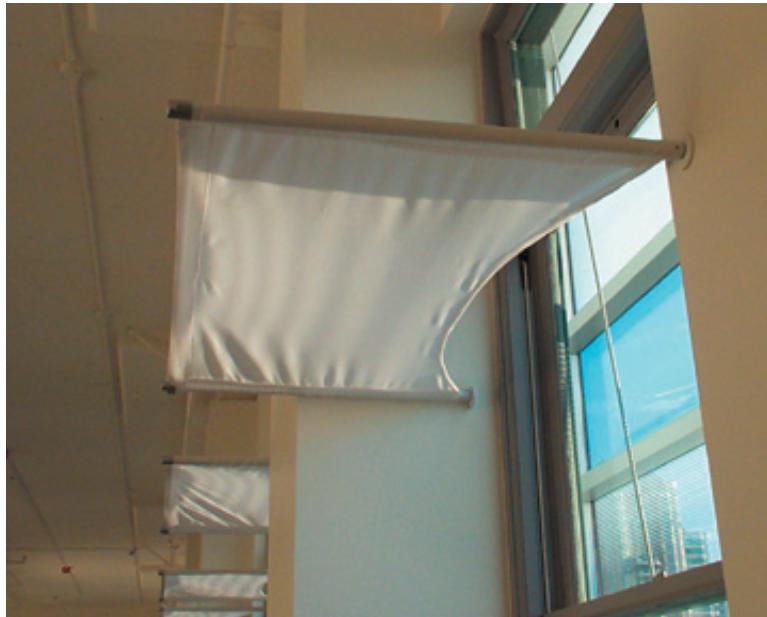
A view of the shading device attached to the interior of the windows. It also serves as a daylight reflector/light shelf to bounce light up to the white painted concrete ceilings.

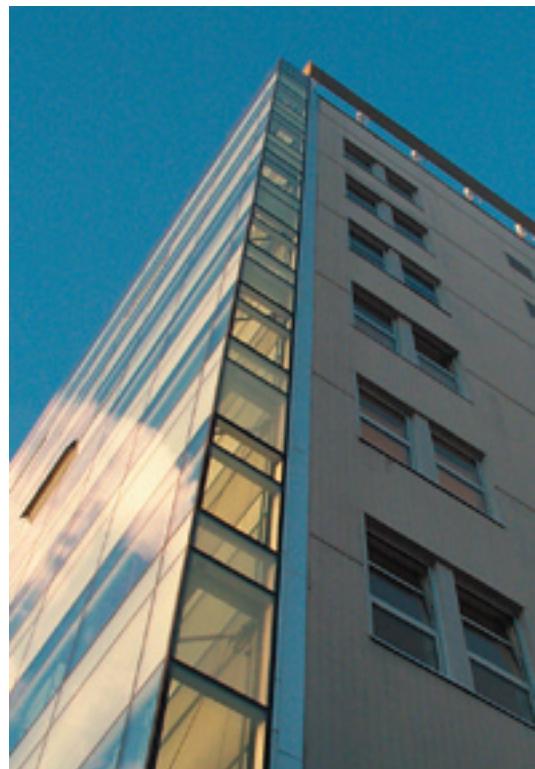
A view of the north east end of the double skin addition clearly showing the depth of the new system.

The overall width of the double skin including cavity is 1200 mm in the Occidental Chemical Building and 900 mm in the Telus Building. It must be recognized that North American architecture, particularly with the office building type, is commercially driven. The 300 mm savings around the perimeter of the building may result in an increase in net leasable area that will assist in offsetting some of the initial capital cost required to construct this type of wall system .

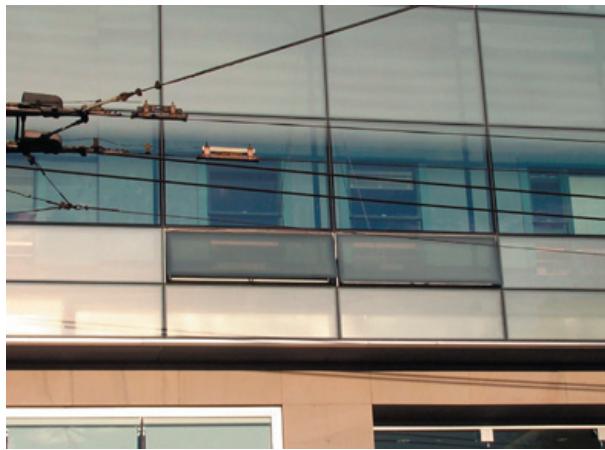
Here we can see the differentiated glazing: clear versus fritted glass, and two of the operable windows in an open position.
